SUMMARY

Auburn's Bag Leak Detectors saved this South Carolina Aluminum Reduction Facility \$200,000 annually by replacing optical technology.

**Auburn's Solution at
the Aluminum Reduction Facility**

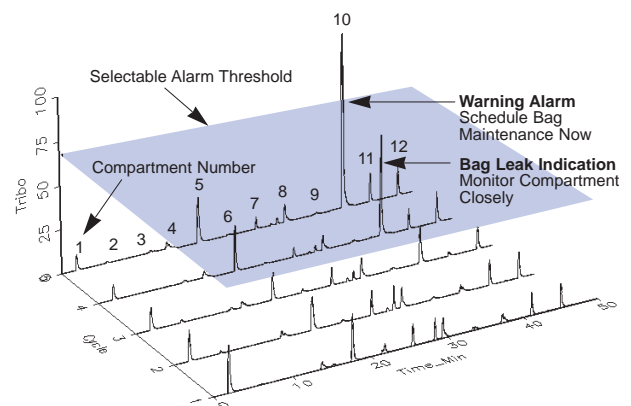
Emissions recorded at the baghouse. Small spikes represent elevated emissions from a normal cleaning cycle and large spikes indicate leaks from torn bags. Auburn equipment located a pencil-sized hole in seconds while the optical sensor was unable to detect a leak until a 8" tear was made.

detect the leak well in advance of visible emissions, minimizing cleanup time. The Tribo.trac Leak Locator allowed the maintenance team to search only 300 bags rather than 3600 bags, reducing the leak locating time to minutes. The optical device did not detect the leak for two days and only after the 1/4" diameter hole had enlarged to an 8" tear. By that time, the amount of dust from the bag leak was over 60 cu ft and took 10 man hours to clean up compared to the 2.6 cu ft of dust accumulated with the Auburn system.

Triboelectric System	Optical Sensor
Estimated Time to:		
Detect Leak	Less than 1 Hour	2 Days
Locate Leak	Less than 1 Minute	2-3 Man Hours
Clean Up Leak	Less than 1 Man Hour	8-10 Man Hours
Estimated Size of:		
Hole Detected	1/4"	8"
Dust Cleanup	2.6 cubic feet	60 cubic feet
Cleanup Tool	Shop Vacuum	Shovels

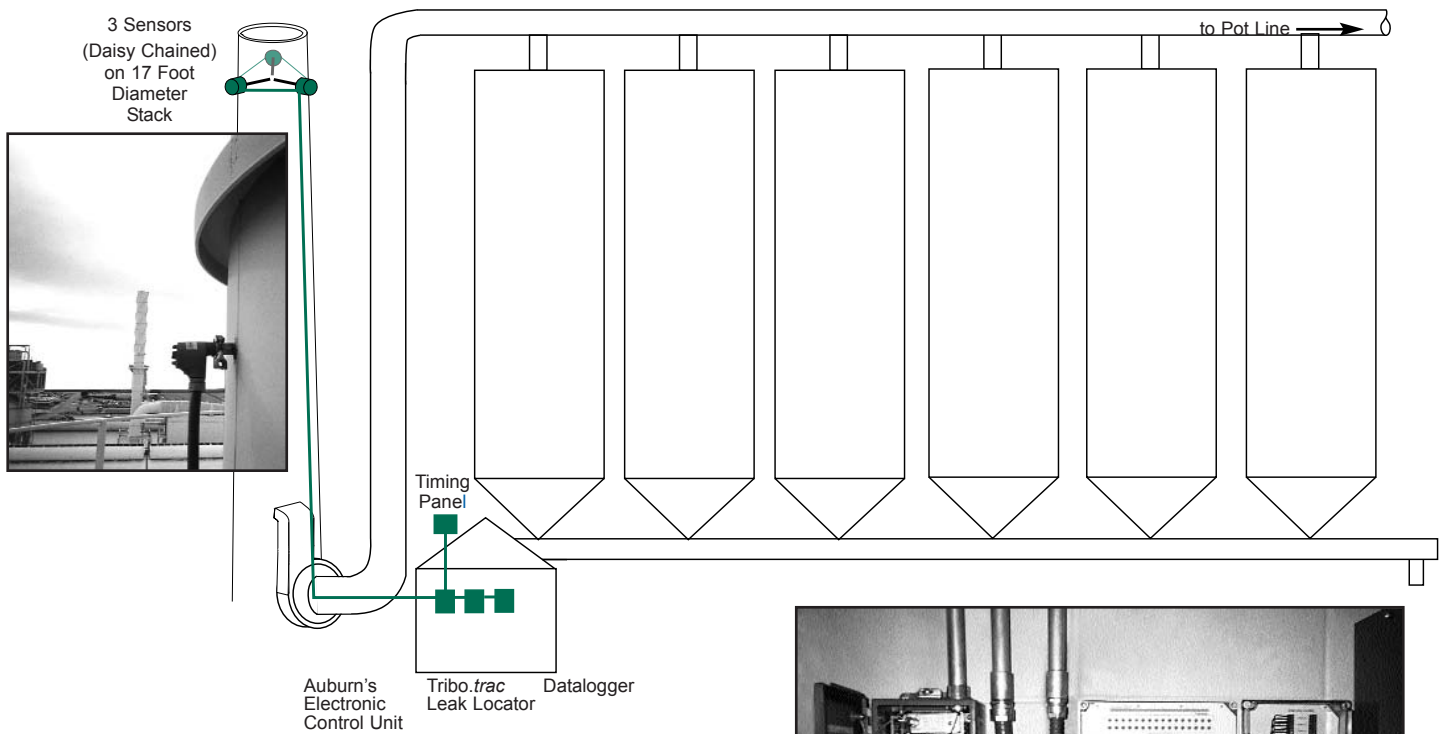
The above diagram shows the aluminum reduction facility's shaker baghouse with six compartments per side, twelve compartments total. Auburn equipment is indicated in green. Inset photos: (Top) A bag leak detector in the stack and (Right) the Control Unit, Tribo.trac Leak Locator and Datalogger.
